APPENDIX E-1
Site Photographs - Cover Soil Area

APPENDIX E-2
Site Photographs – Shaft Sites

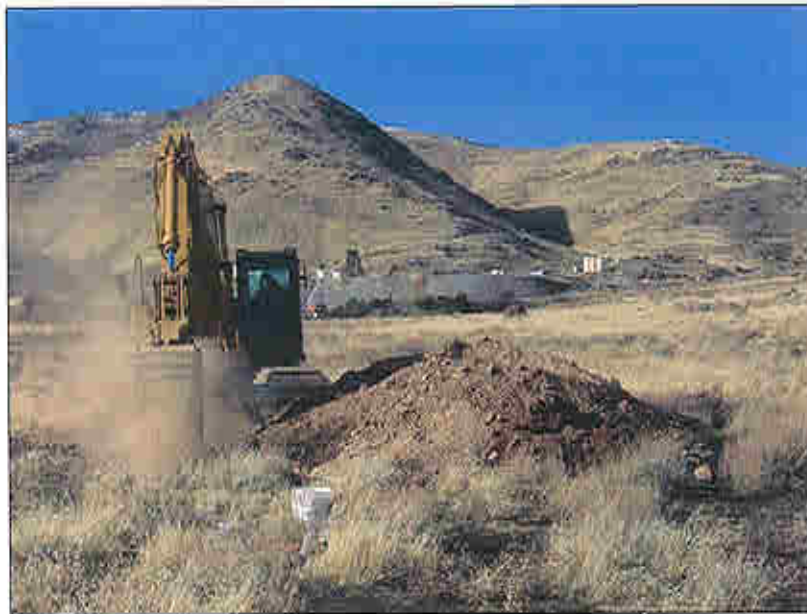
Photograph No. 1. Site conditions at the potential cover soil source area located northeast of the main Gooseberry mine shaft (head frame in background). The track hoe is excavating Test-Pit No. TP-6. Photograph taken by AMEC personnel on February 2, 2006.

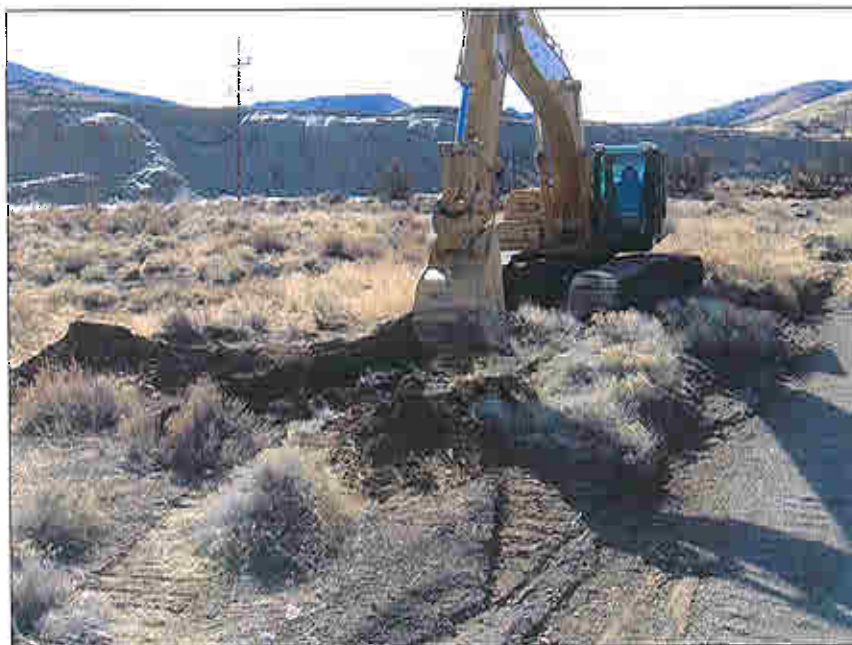
Photograph No 2A. Site conditions potential cover soil source area showing the track hoe excavating Test-Pit No. TP-11 located north of the heap leach pad. Photograph taken by AMEC personnel on February 3, 2006.

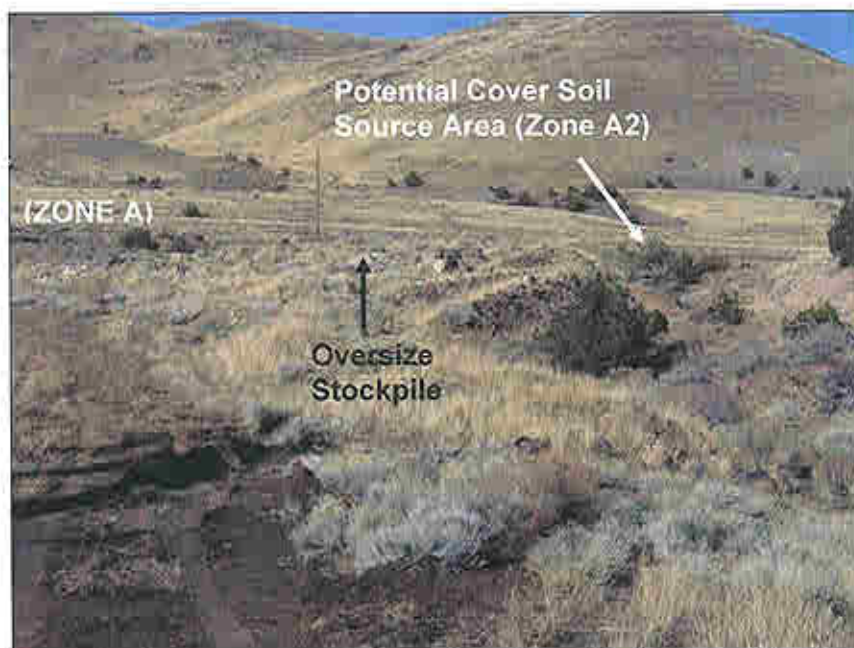
Photograph No. 2B. Site conditions at the potential cover soil target area looking north along Martin Canyon. Zones A and A2 are shown and correspond to the areas shown in Figure 2B. Photograph taken by AMEC personnel on February 3, 2006.

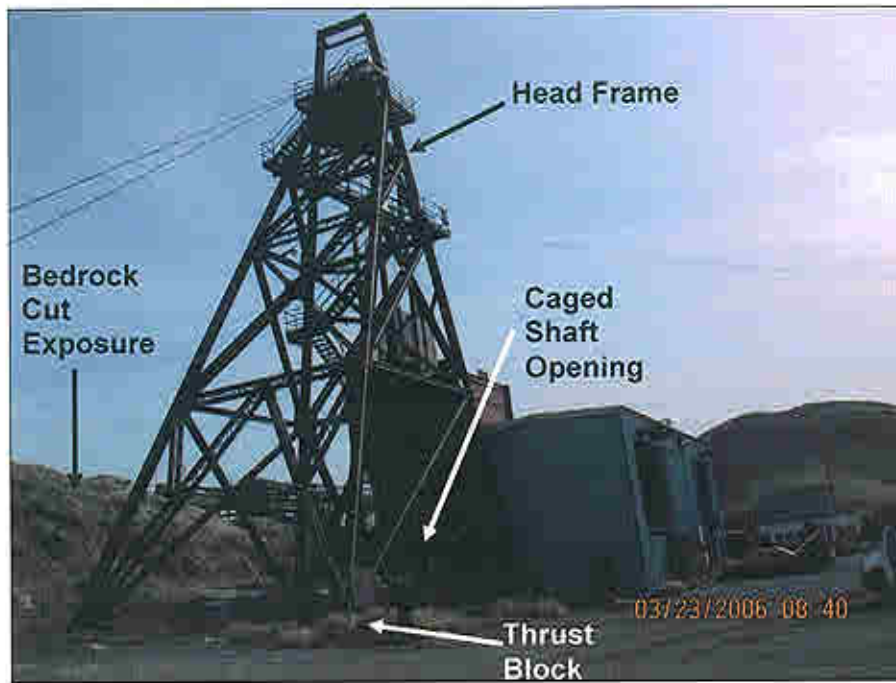
Photograph No. 3. Site conditions at the main Gooseberry mine shaft showing the head frame, adjacent mine building, and bedrock exposed in the cut slope (lower left corner). Photograph taken by AMEC personnel on March 23, 2006.

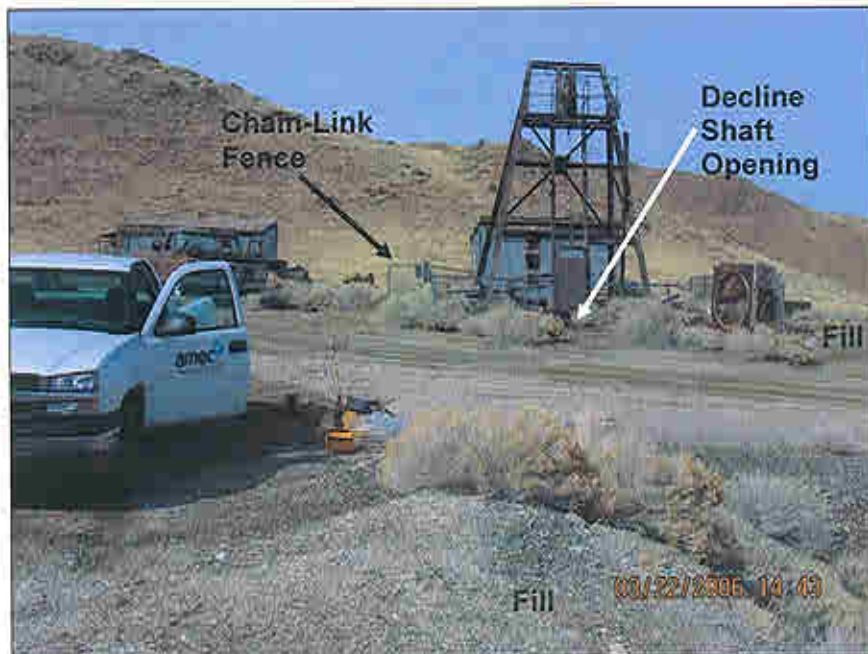
Photograph No. 4. Site conditions at the (secondary) decline mine shaft showing the head frame, access roads, and adjacent small mine buildings. Photograph taken by AMEC personnel on March 22, 2006.

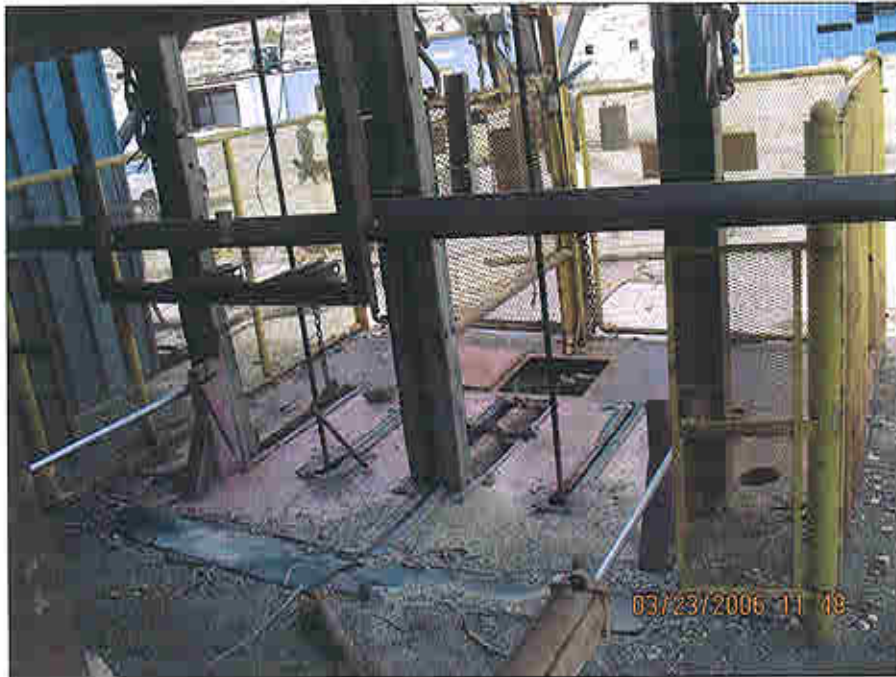
Photograph No. 5. Site conditions at the main Gooseberry mine shaft collar showing the locked cage (in yellow) and other steel structures. Photograph taken by AMEC personnel on March 23, 2006.

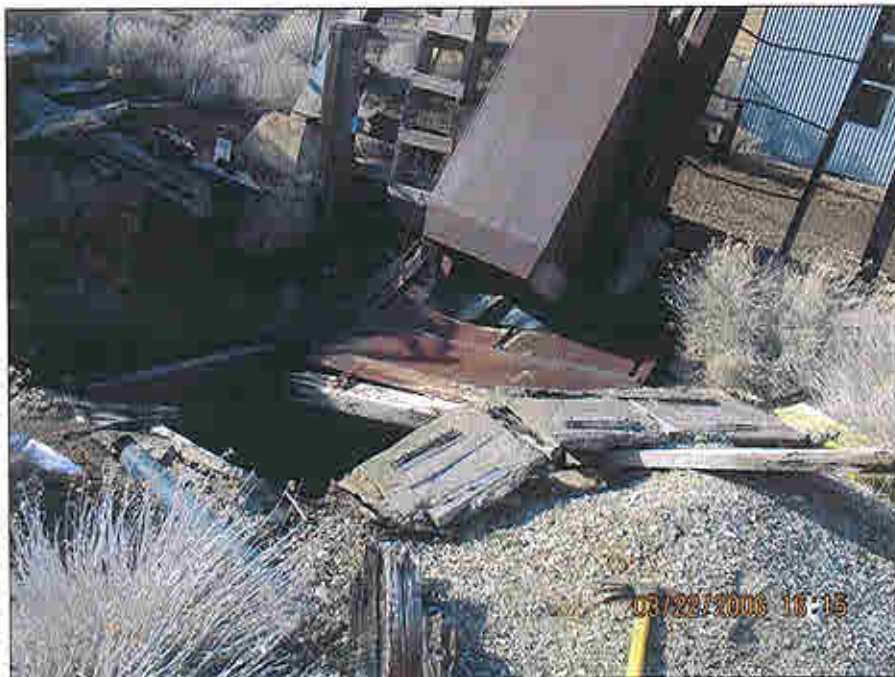
Photograph No. 6. Site conditions at the (secondary) decline shaft collar. Photograph taken by AMEC personnel on March 22, 2006.
